APPENDIX B: FIELD REVIEW

US 58 Field Review

Conducted: June 12, 2018

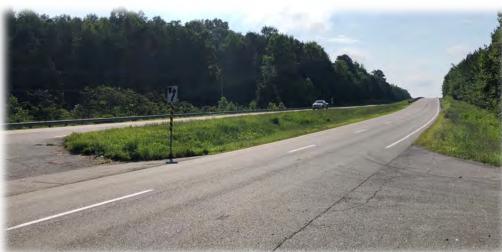
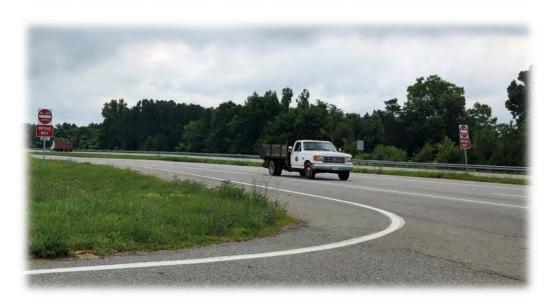
US 58 Business to US 15 Interchange

- Partial controlled access
- Close proximity of Rte. 723 intersection to interchange
- 8ft paved shoulders

- Level terrain
- 8ft paved shoulders
- Limited access section around Clarksville
- Some closely spaced intersections
- Rte. 92 Intersection controlled with flashers
 - Limited sight distance for EB approach
 - WB right-turn lane is sub-standard

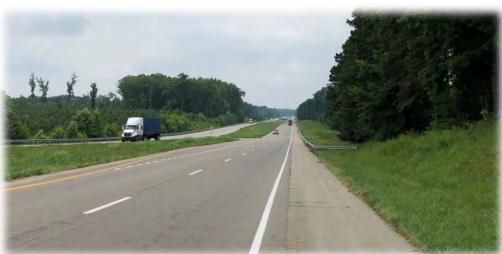
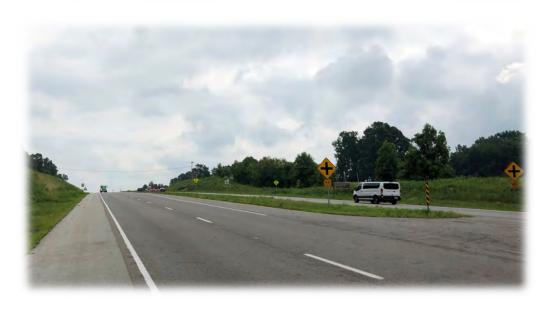
• Rte. 92 (Washington St.) to Rte. 4 (Buggs Island Rd.)

- Numerous crossovers and increasing access on this segment
- Rte. 4 intersection has steep inclines on both US 58 approaches. May limit sight distance on side streets

- More rolling terrain may be problematic for heavy vehicles
- Minor intersections with sight distance concerns
- Redundant crossovers
- Cross slope at US 1 intersection not ideal for trucks

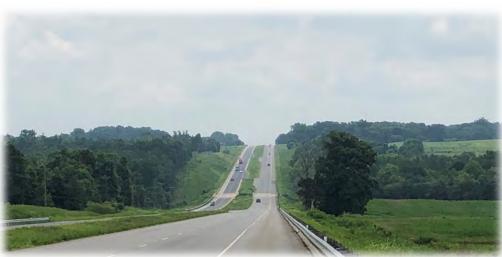
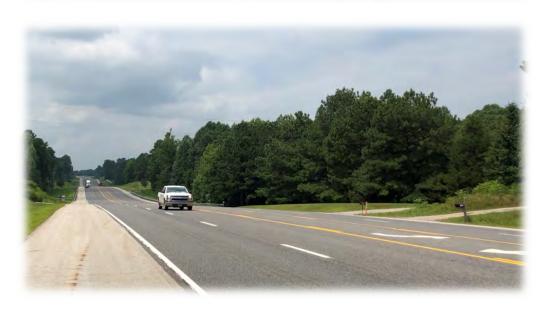
• Western US 1 Intersection to Rte. 780 (Theater Rd.)

- TWLTL between US 1 intersections
- Increase in direct access to US 58
- Accel lane onto WB US 58 at eastern US 1 intersection appears short.
- Some sight distance concerns at Rte. 780 intersection

- 8' 10' paved shoulders
- Minimal access and crossovers
- Rte. 643 intersection in close proximity to I-85 interchange

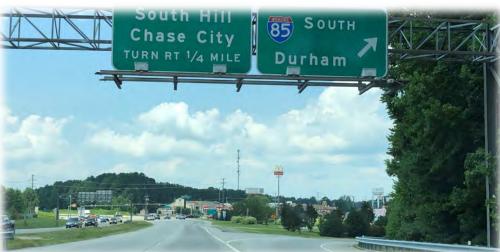
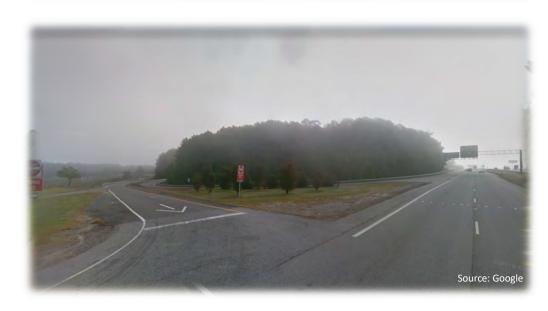
• I-85 / US 58 Interchange

- SB I-85 to WB US 58 has improper through movement pavement marking leading to a small gravel section in the median
- T-intersection for SB I-85 to WB US 58 may be problematic for trucks entering the roadway
- No turn lane or taper for WB US 58 to NB I-85

- Motorists cutting across EB US 58 from NB I-85 off ramp to entrance of Shell gas station. (Less than 600')
- Numerous access points and median crossovers
- Shaw St. / Cycle Ln. has a significant grade disparity between EB and WB US 58
- Rte. 621 intersection:
 - Side street approaches have steep grades and sharp curves
 - Lots of access points around intersection

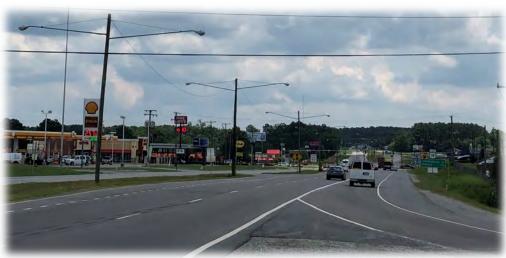
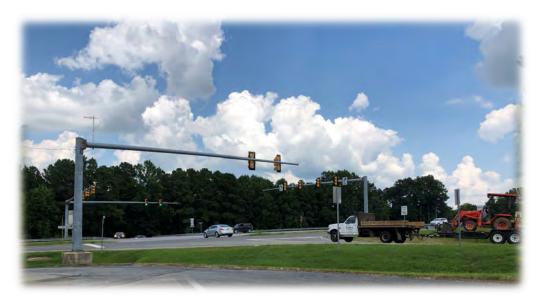
• Rte. 621 (N. Main St.) to Town of Brodnax

- Inconsistent shoulder width and type
- Crossovers lacking turn lanes
- Rolling terrain

- TWLTL throughout
- Lots of direct access
- 4' grass / gravel shoulders

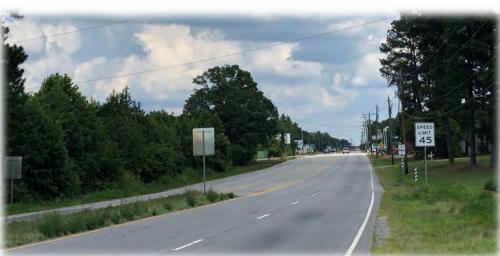
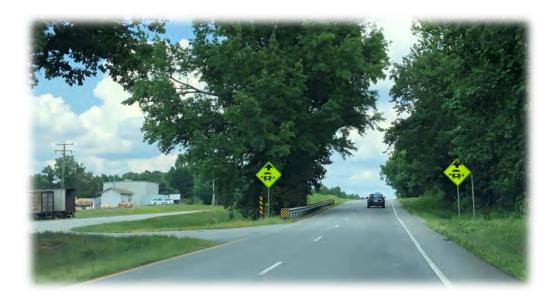
• Town of Brodnax to Rte. 644 (Robinson Ferry Rd.)

- Variable shoulder width and type
- Crossovers without turn lanes
- Sight distance concerns to some crossovers due to rolling terrain
- Sub-standard turn lanes and a cross slope through the intersection with Rte. 644

- Crossovers without turn lanes
- Sight distance concerns to some crossovers due to rolling terrain
- 4' paved or gravel shoulders

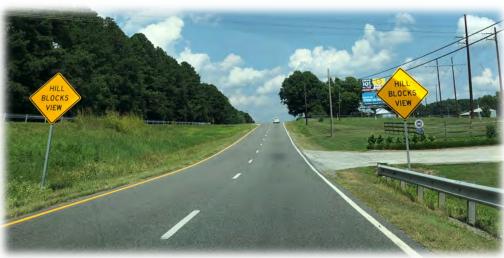
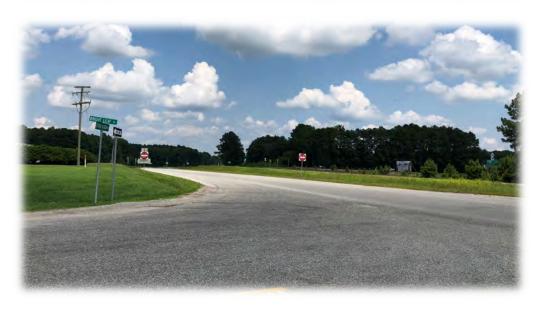
- Limited Access until near Rte. 641
- Sub-standard turn lanes for crossovers on the eastern portion
- Rte. 641 intersection:
 - Skewed intersection
 - Wide median may make it difficult for trucks

- Lots of commercial activity
- Redundant crossovers and many lack turn lanes
- Rte. 712 intersection:
 - Controlled by overhead flashers
 - Grade differential between EB and WB US 58 may be difficult to cross
 - Decision making may be difficult due to width of median

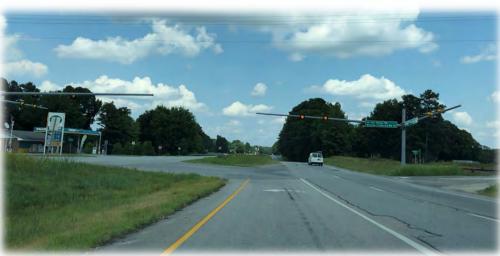
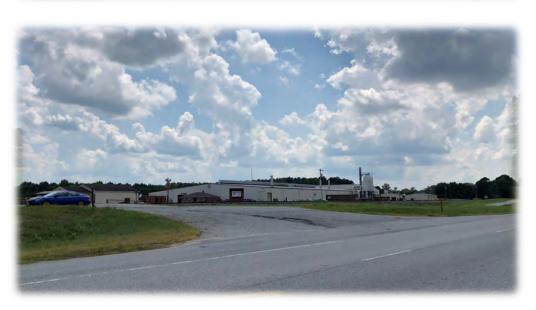
• Eastside Rd. to Brunswick Co. Line

- Rolling Terrain
- Varying should types and widths
