Walkabout Summary

On October 4, 2013 four participants met at Enderly Heights Elementary School in Buena Vista, Virginia to take a closer look at the walking and biking network around the school. Participants included representation from the Buena Vista City Schools, Enderly Heights Elementary School, the Central Shenandoah Planning District Commission, and Buena Vista city council. The team observed the student dismissal procedure, walked a potential student walking route around the school, examined the nearby streets, and discussed the potential barriers to safely walking and bicycling to school.

Location: Enderly Heights Elementary

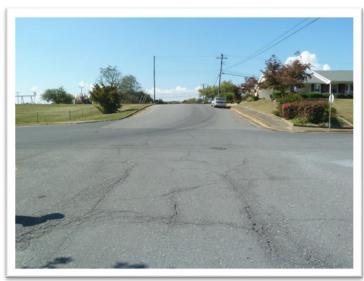
2nd Street, looking west. There are no cross walks on the intersection of 2nd Street and Woodland Avenue

not continue north of 3rd Street. Pedestrian crossing facilities such as marked crosswalks, school crossing signs, and curb ramps are absent at the intersection of 2nd Street and Woodland Ave (marked as "A" on the map). Additionally, there are no stop bars on Woodland Avenue. The team observed that the higher grade on 2nd Street to the west of the intersection limits visibility for all users. The team said that the neighborhood would be receptive to traffic calming measures along Woodland Avenue and at the intersections to make walking and biking more comfortable for people of all ages and abilities.

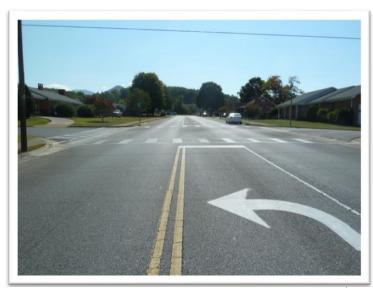
3rd Street connects Magnolia Avenue, one of the main arterial roads in Buena Vista, with the high school, which is why it experiences relatively a higher volume of traffic when compared other residential streets in the neighborhood. This is the only intersection on Magnolia Avenue that has pedestrian crossing facilities (marked on the map as intersection "C"). It has high visibility crosswalks on three approaches.

Magnolia Avenue, looking south. The intersection of Magnolia Avenue and 3rd Street is the only intersection on Magnolia Avenue near the school with crosswalks.

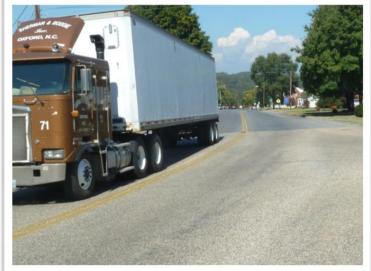
Magnolia Avenue is difficult to cross because of the high volumes of motor vehicle traffic, and the lack of pedestrian infrastructure at intersections. Magnolia Avenue is the main thoroughfare through town and is a common route for truck freight. The team mentioned that parents are concerned about

Magnolia Avenue, looking north. Magnolia Avenue is often used a common route through Buena Vista.

students crossing the road amongst large vehicles. The team recognizes that a significant number of students live west of Magnolia Avenue and would need to cross the road to walk or bike to school. The team believes that when pedestrian improvements are made at 3rd Street and Magnolia Avenue, students would be more comfortable and more likely to walk or bike to and from school.

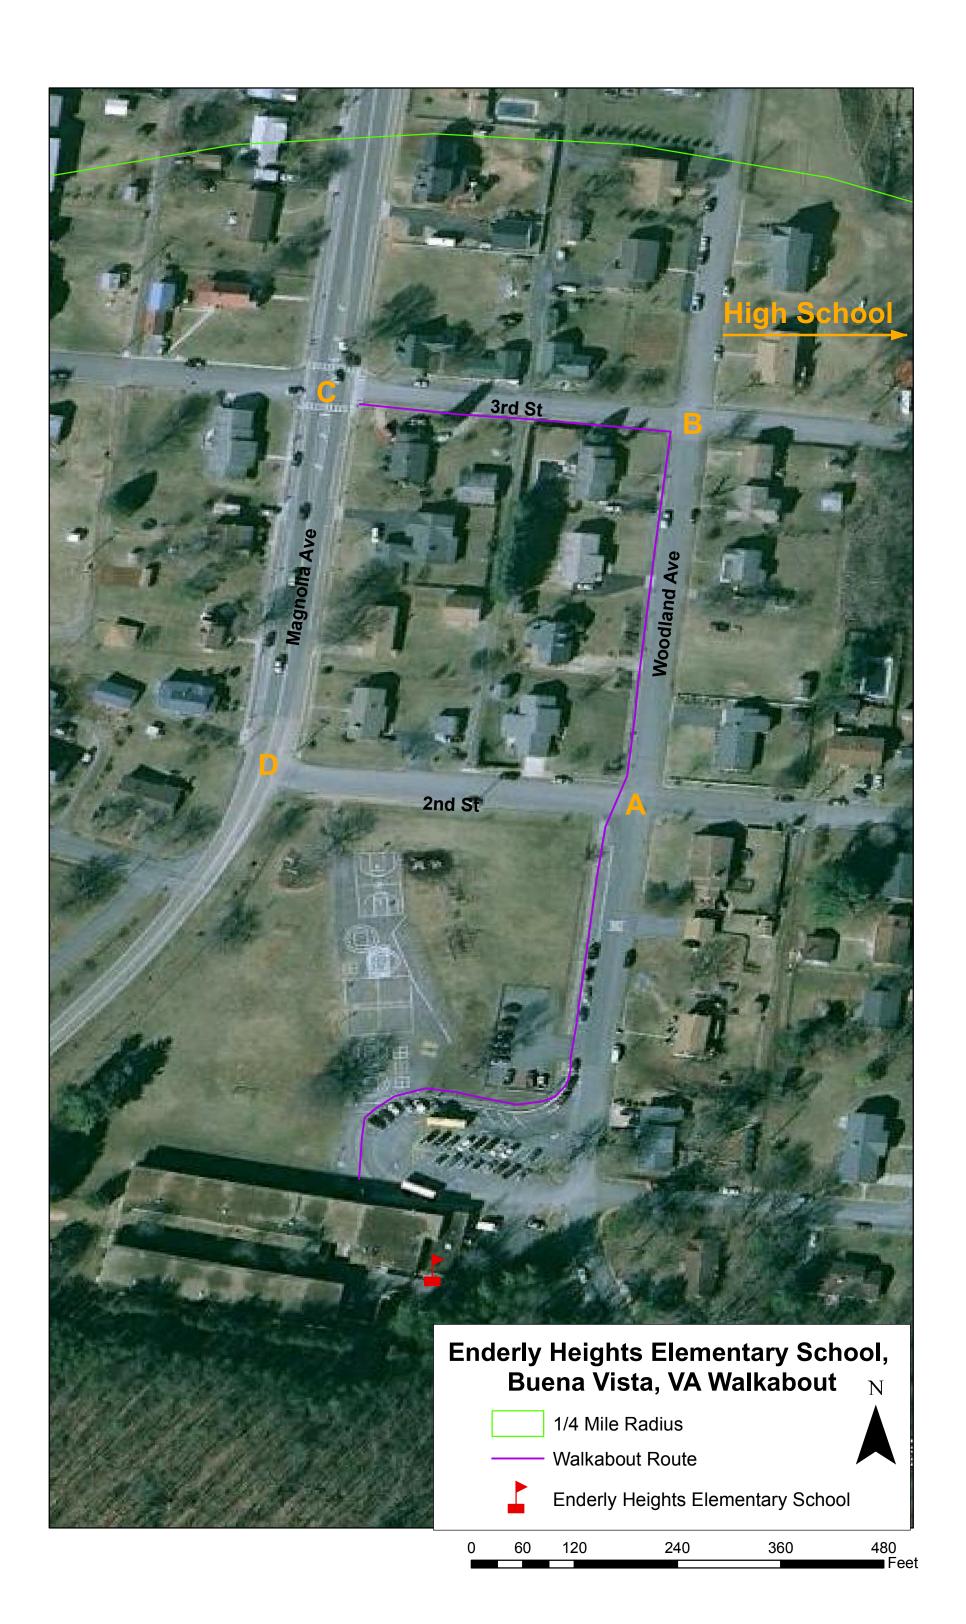
The attached map shows the walkabout route and the locations of the observed streets.
