APPENDIX B: FIELD REVIEW

US 58 Field Review

Conducted: June 12, 2018

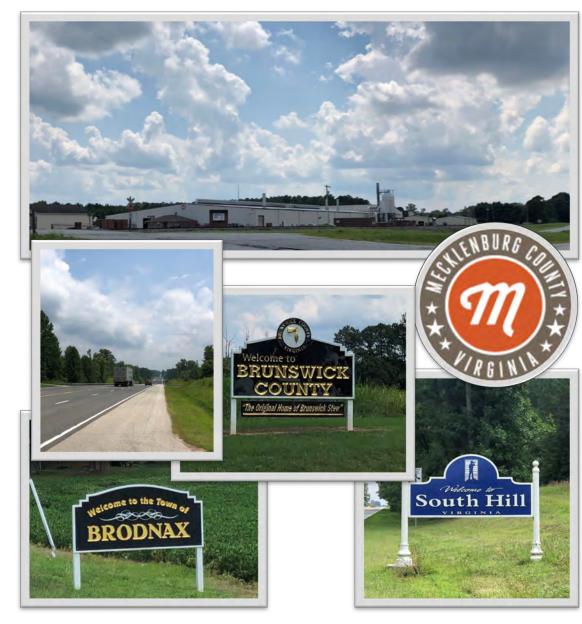
- Rolling terrain
- Intersection and crossovers with sub-standard turn lanes
- Mix of shoulder type
 - Portions without a paved shoulder
 - Widens to 4ft (EB) and 8ft (WB) gravel shoulders
- Grade differentials between EB and WB at intersections and crossovers
